**Flood Control Project Maintenance  
Levee Inspections**

**Fall 2013 Levee Maintenance Deficiency Summary Report**

**Sutter Maintenance Yard Maintenance Area 0017**

Waterway			Bank	Unit Miles
Unit No. 01 Lake County Sutter Maintenance Yard - Middle Creek			Left	3.90
	Spring (March - May)	Summer (June - August)	(September - November) Fall	Winter (December - February)
Unit Maintenance Rating (Fall Only)			U	
Date of Inspection	03/13/2013 - 03/13/2013		10/11/2013 - 10/11/2013	
DWR Inspector	Bob Duffey		Bob Duffey	
Accompanied By	Bryan Reniff Sutter Maintenance Yard		Bryan Reniff Sutter Maintenance Yard

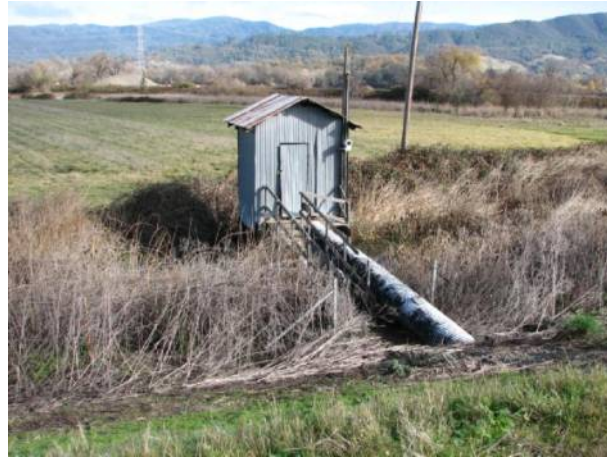
Levee Mile Report Line	5
Start Levee Mile	3.97
End Levee Mile	3.97
Location	Water Side
Category	Supplemental
Item	DWR UCIP Field Study

Pumphouse on piles at LS toe.

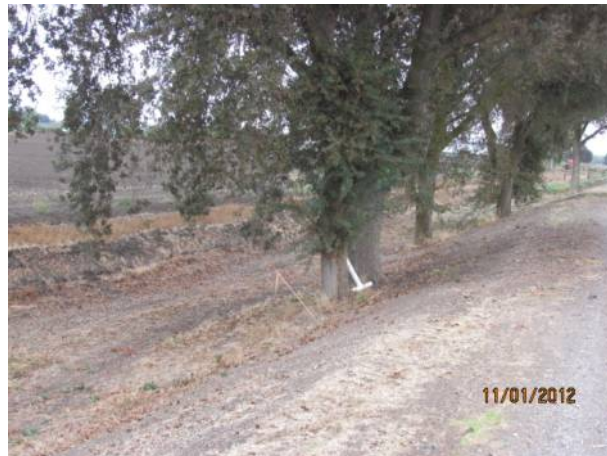
Levee Mile Report Line	7
Start Levee Mile	4.18
End Levee Mile	7.31
Location	Water Side
Category	Earthen Levee
Item	Vegetation

View of the six-foot crown levee & heavy vegetation on waterside slope.

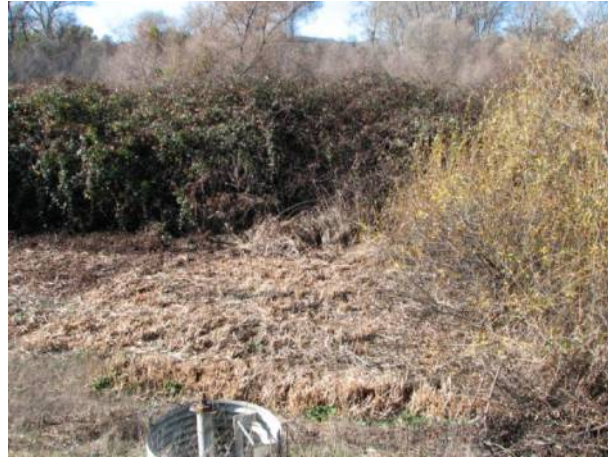
Levee Mile Report Line	9
Start Levee Mile	4.28
End Levee Mile	4.28
Location	Land Side
Category	Supplemental
Item	DWR UCIP Field Study

LMR No.	Levee Mile		Category	Item	Location	Rating	Action/Comment	GPS Latitude/Longitude		Issue No.
	Start	End						Start	End	
9	4.28	4.28	Supplemental	DWR UCIP Field Study	LS	M En	Inspector Comments: FS_ID:16867 EP_NO: N/A Repair Type: Non-Urgent Crossing Status: Found UCIP Comments: No lid on riser-may or may not be an issue.8/2/2013 Same as last inspection. FIELD_STRUCT_DESC: 24-inch CMP drainpipe through the levee, 19 feet below the crown. Slide gate in 36-inch CMP riser on the waterward slope (USCE 1909). FS Date: 8/5/2013 7:01:10 AM	39.140422 ° -122.902022 °	39.140422 ° -122.902022 °	36 Y
DWR ID: DWR_MA0017_01_f_2013_36										
10	5.07	5.07	Earthen Levee	Vegetation	LS	A Ma	V1 : Control annual grass and weeds on the levee slopes and easements. Inspector Comments: Sutter Yard has mowed the landside slope & berm.	39.130896 ° -122.896643 °	39.130896 ° -122.896643 °	61 Y
DWR ID: DWR_MA0017_01_f_2013_61

Slide gate in CMP riser on WS slope.

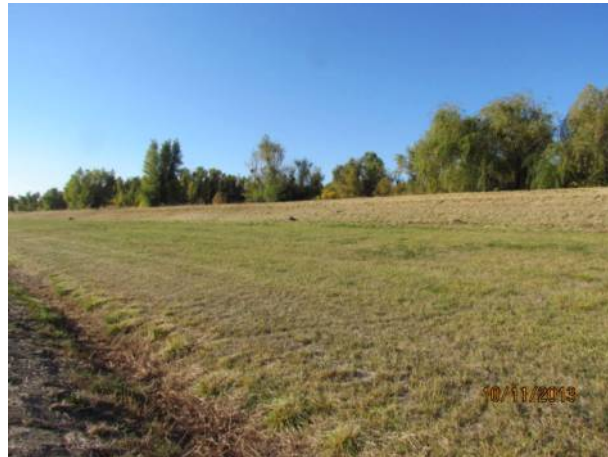
Levee Mile Report Line	10
Start Levee Mile	5.07
End Levee Mile	5.07
Location	Land Side
Category	Earthen Levee
Item	Vegetation

View of the mowed landside slope & berm.

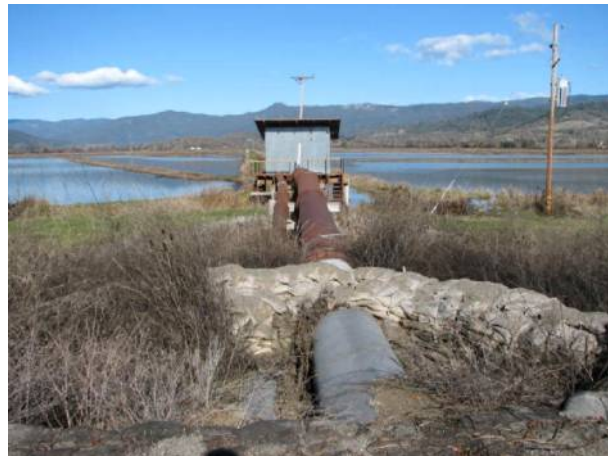
Levee Mile Report Line	14
Start Levee Mile	5.38
End Levee Mile	5.38
Location	Land Side
Category	Supplemental
Item	DWR UCIP Field Study

14	5.38	5.38	Supplemental	DWR UCIP Field Study	LS	M En	Inspector Comments: FS_ID:16868 EP_NO: 11469 Repair Type: Non-Urgent Crossing Status: Found UCIP Comments: flood fight materials-ring levees around both LS and WS slopes at pipe crossing. This may or may not be an issue.8/2/2013 Same as last inspection. FIELD_STRUCT_DESC: 1 of 2: 16 inch steel drainpipe through the levee 5-feet below the crown. Drainage pumping plant on the landward side. Flap gate on the waterward end. (ABO No.11469-R.D.# 2070). This entry matches the Drainage/Irrigation Structure referenced in O&M manual (Levee Mile 5.43). Permit document and O&M referred As-built drawings are available. O&M manual Vol. 5, Revision Year 2010. FS Date: 8/5/2013 7:01:53 AM	39.127449 ° -122.893460 °	39.127449 ° -122.893460 °	40 Y
----	------	------	--------------	-------------------------	----	---------	--	------------------------------	------------------------------	---------

Pumping plant, pipes, and ring levees on LS toe.

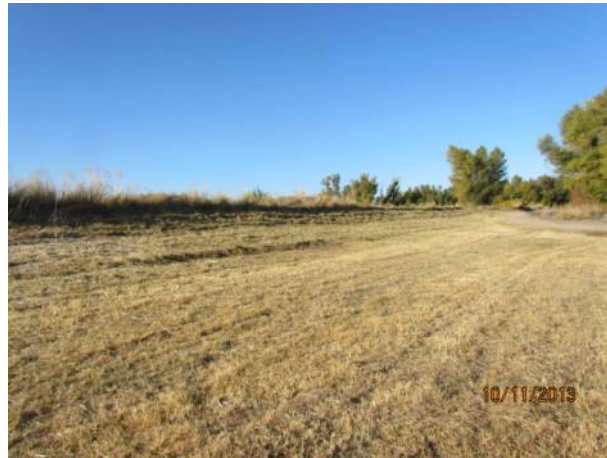
Levee Mile Report Line	17
Start Levee Mile	5.45
End Levee Mile	5.45
Location	Land Side
Category	Earthen Levee
Item	Vegetation

View of the landside slope & berm.

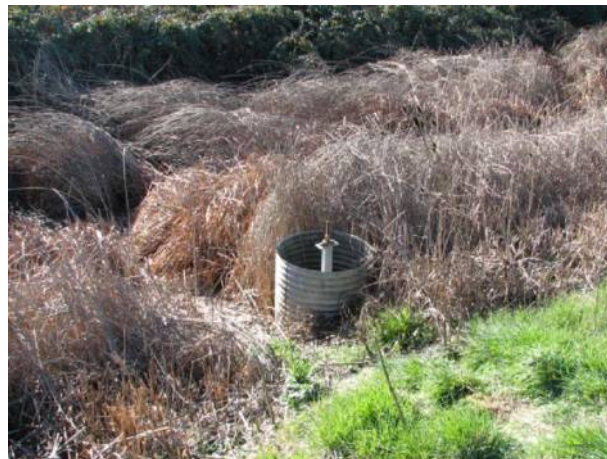
Levee Mile Report Line	19
Start Levee Mile	5.81
End Levee Mile	5.81
Location	Land Side
Category	Supplemental
Item	DWR UCIP Field Study

LMR No.	Levee Mile		Category	Item	Location	Rating	Action/Comment	GPS Latitude/Longitude		Issue No. Photo
	Start	End						Start	End	
19	5.81	5.81	Supplemental	DWR UCIP Field Study	LS	M En	Inspector Comments: FS_ID:16870 EP_NO: 11457 Repair Type: Non-Urgent Crossing Status: Found UCIP Comments: No cover on CMP riser and no handle for actuating gate. This may or may not be an issue.8/2/2013 Handle to operate gate was in place but still no cover on riser. FIELD_STRUCT_DESC: 24-inch drainpipe under patrol road and through the levee, 13.5 feet below the crown. Concrete "U" shaped headwall on the landward end. Slide gate in 36-inch CMP riser on the waterward slope. Riser unit is mounted on concrete base. (ABO No.11457-Crawford). O&M manual Vol. 5, Revision Year 2010 FS Date: 8/5/2013 7:03:13 AM	39.127612 ° -122.885520 °	39.127612 ° -122.885520 °	44 Y
DWR ID: DWR_MA0017_01_f_2013_44										
20	6.02	6.02	Supplemental	DWR UCIP Field Study	LS	M En	Inspector Comments: FS_ID:8769 EP_NO: N/A Repair Type: Non-Urgent Crossing Status: Found UCIP Comments: No permit for crossing. FIELD_STRUCT_DESC: 12-inch HDPE storm drain pipe through the crown of the levee 1.5-feet below the crown. FS Date: 10/16/2012	39.126057 ° -122.883096 °	39.126057 ° -122.883096 °	45

36-inch CMP riser and slide gate on WS slope.

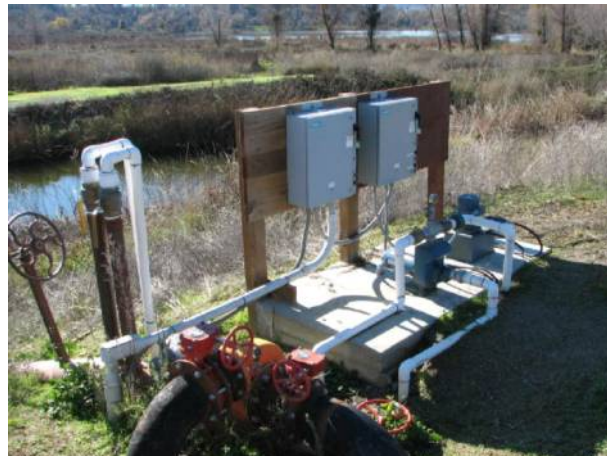
Levee Mile Report Line	26
Start Levee Mile	6.03
End Levee Mile	6.03
Location	Land Side
Category	Supplemental
Item	DWR UCIP Field Study

Pump station on LS shoulder, see hydraulic pump at right.

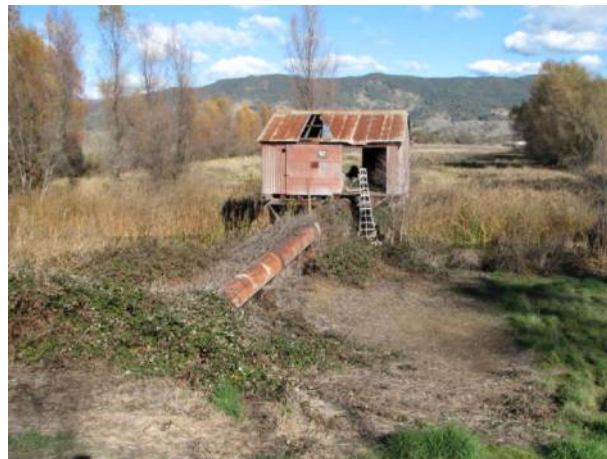
Levee Mile Report Line	34
Start Levee Mile	7.19
End Levee Mile	7.19
Location	Crown
Category	Supplemental
Item	DWR UCIP Field Study

Pumping plant in shed on LS at drainage ditch.
